Chilworth Gunpowder Mills - Middle Works

Assessment of Building Sequence

West Lodge

Blacksmith Lane, Chilworth, Surrey (Building No 46 English Heritage Survey 2003) NGR TQ 02485 46477

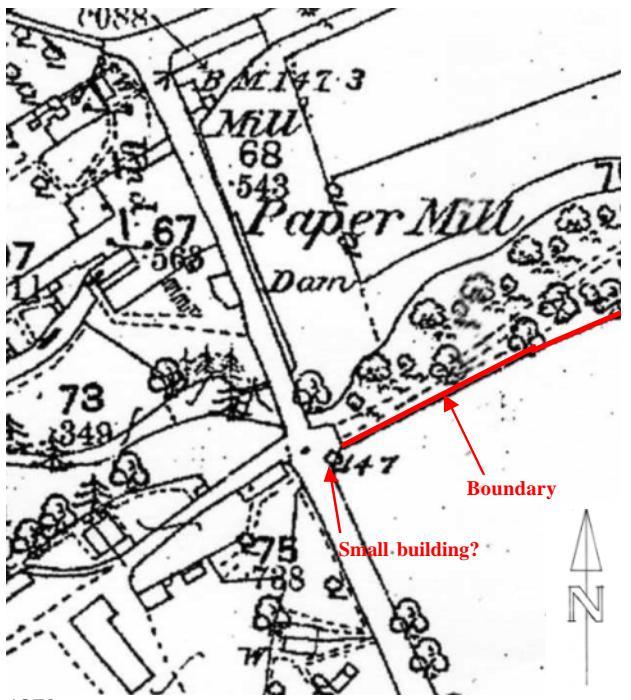
The 1870 Ordnance Survey map appears to show a small structure adjacent to the entrance way albeit at a slightly different orientation. A line across the entrance to the east of this seems to correspond with the position of the present iron entrance gates. This suggests to me that any structure that existed at that time already served to control access.

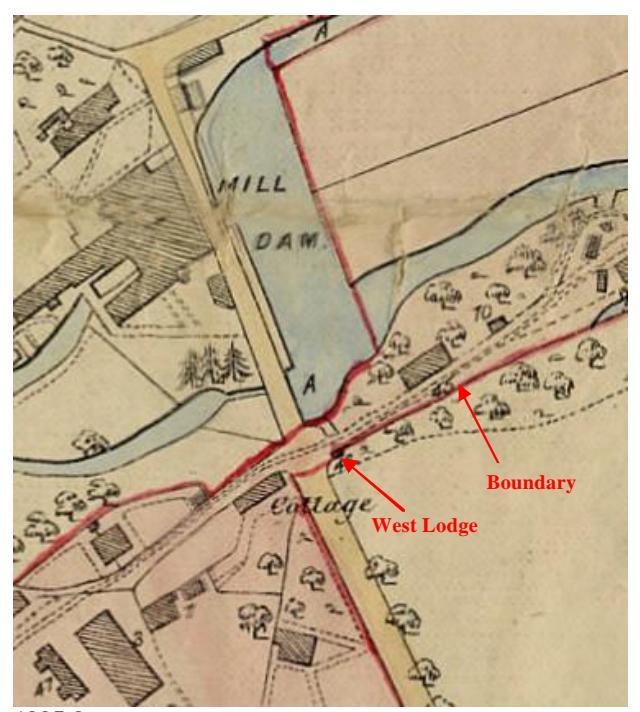
1885-8 Estate Map, Warner Collection

The original Entrance Lodge part of West Lodge appears to have been built by the time of the 1885-8 Estate map and is shown on all subsequent maps, with the "enlargement" not being shown until the 1934 Ordnance Survey Map.

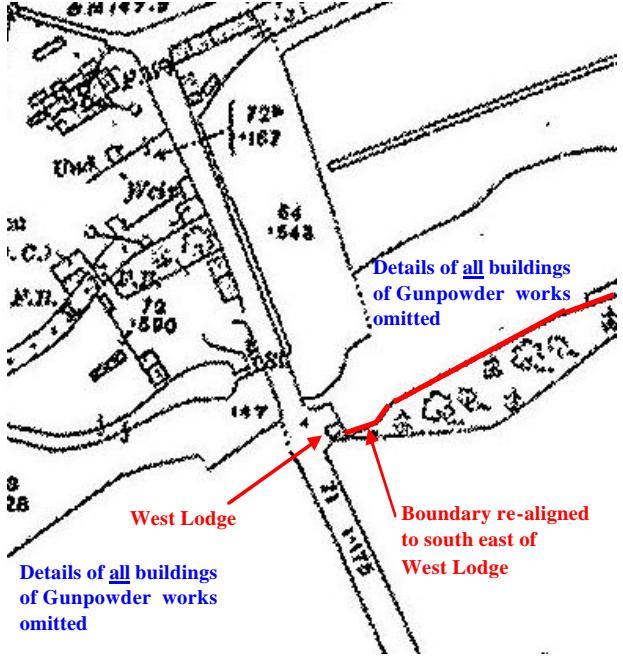
1916 **Ordnance Survey**

However, on the 1916 Ordnance Survey map the boundary by West Lodge is shown re-aligned for a short distance corresponding with the position of the "enlargement", this re-aligned position being maintained on the 1934 Ordnance Survey map. This points to the "enlargement" of West Lodge having already been made by the time of the 1916 Ordnance Survey map, but for security omitted from the map together with all other structures and detail within the Gunpowder works.

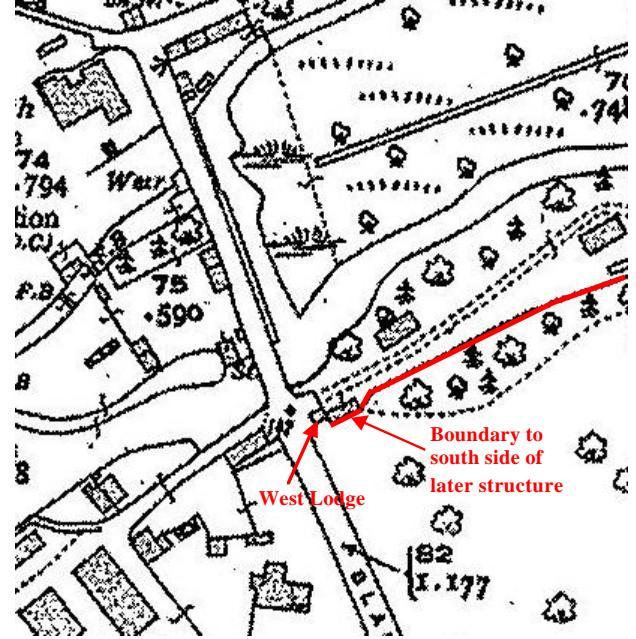
1934 **Ordnance Survey**

Comparison of the Ordnance Survey and estate Maps show the original Lodge Building having existed at least by 1885 and remaining unchanged in 1896. A change in the boundary alignment to the south of the original Lodge building as shown on the 1916 and 1934 Ordnance Survey Maps point to the "enlargement" of the Entrance Lodge having been carried out by 1916, although the additional structure was not shown until the 1934 edition.

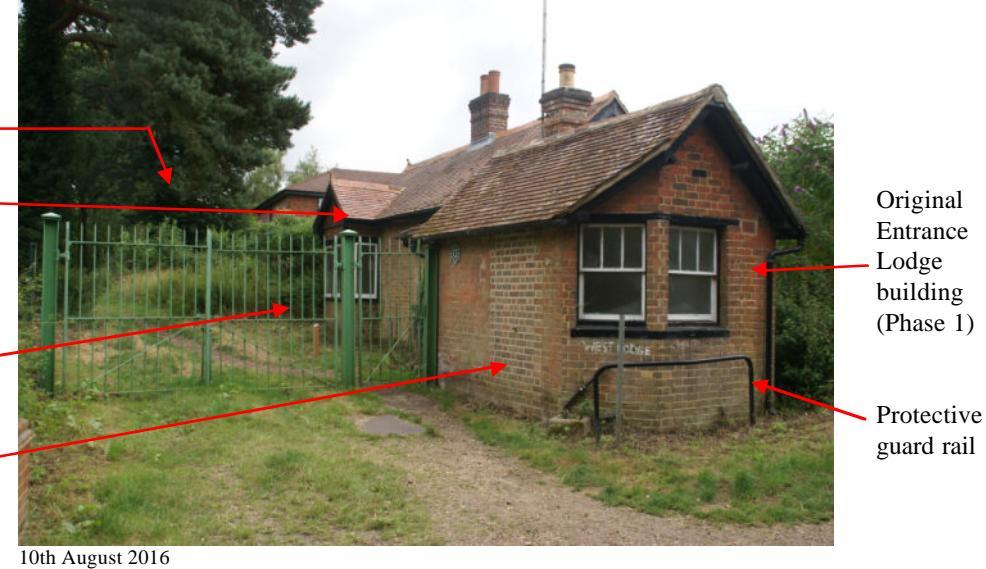
Front (West) Elevation

Later 2-Room – structure at rear (Phase 2)

Entrance gates (aligned with rear – north east corner of Lodge)

Original Entrance Lodge building (Phase 1)

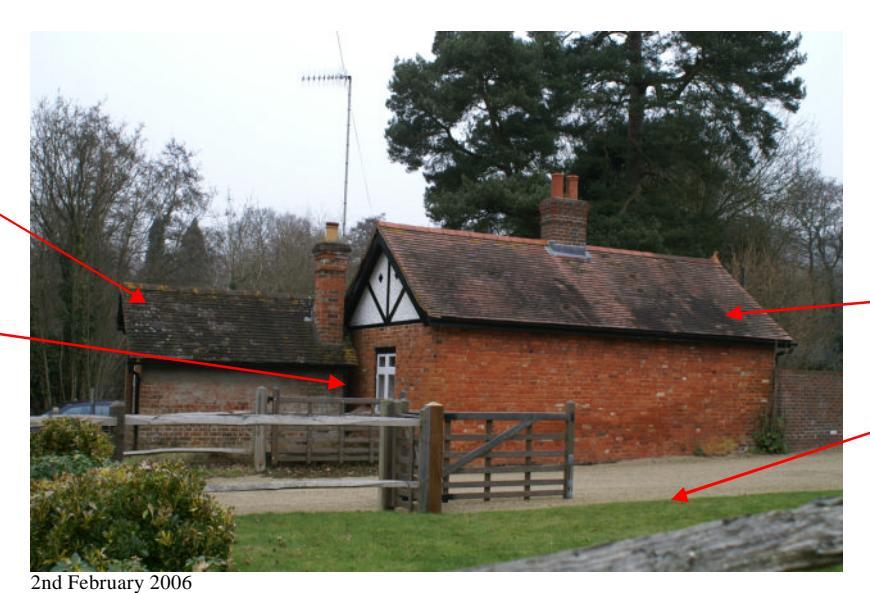
South Flank Elevation

Bricked up – doorway (Phase 4)

Gap between independent structures (Later closed on north side by Phase 3 link structure)

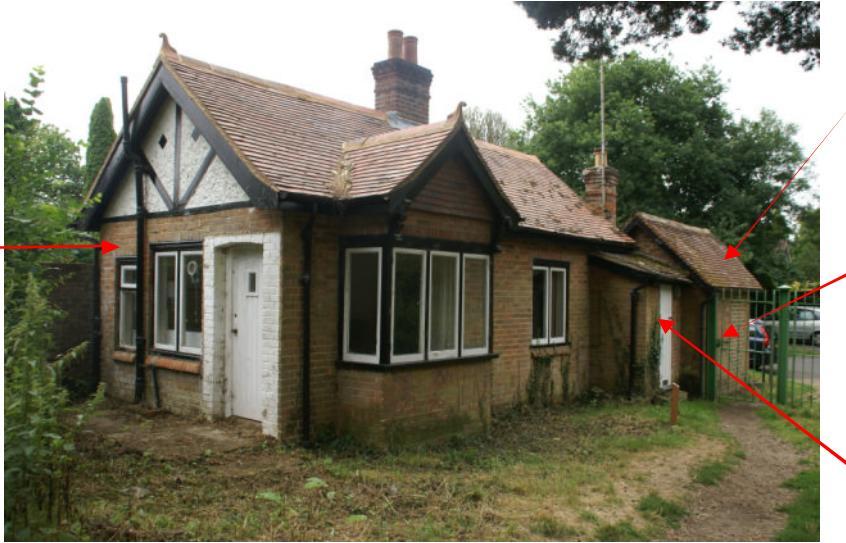
View from North

Later 2-Room structure at rear (Phase 2)

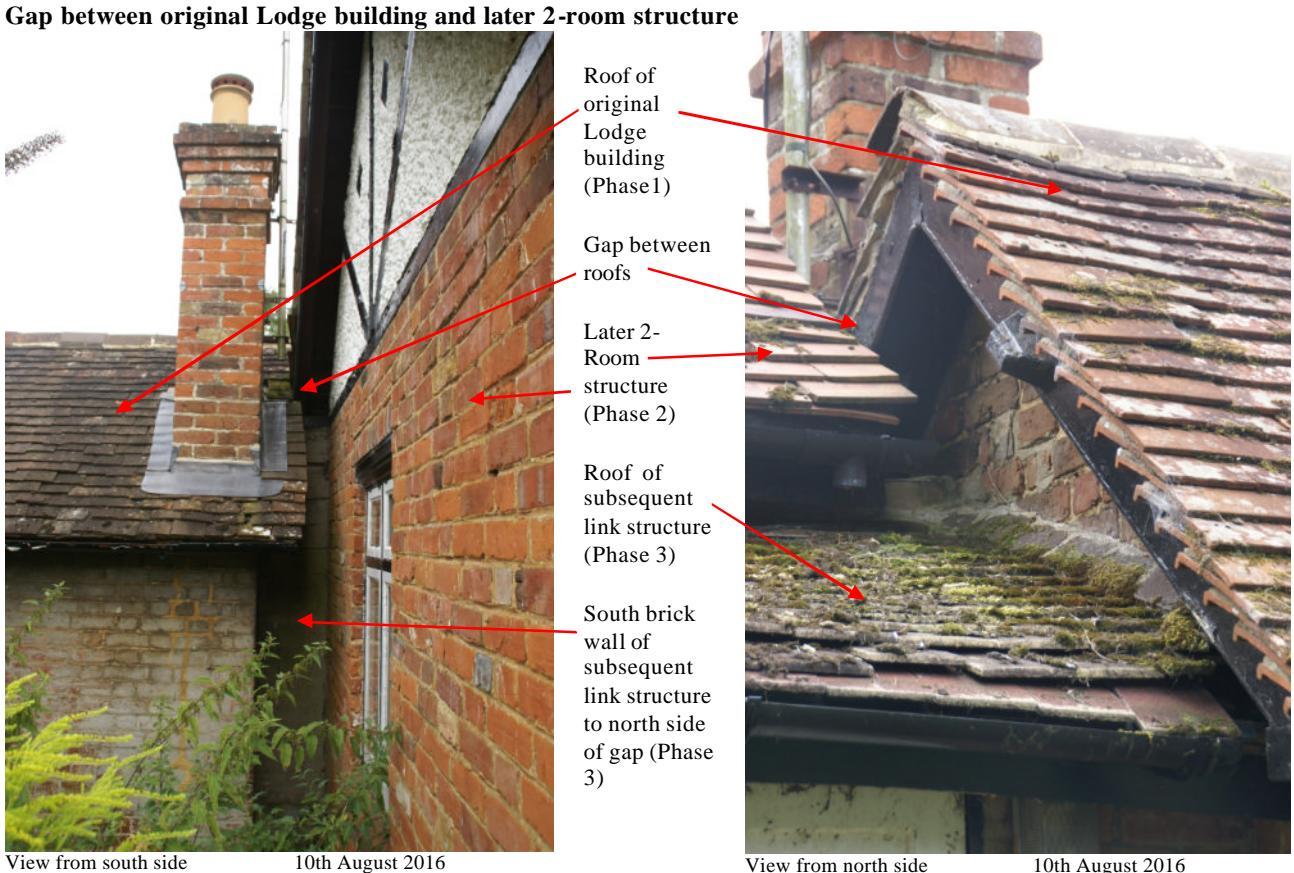
View from north side

Subsequent Link structure (Phase 3)

Later inserted door opening (Phase 4?)

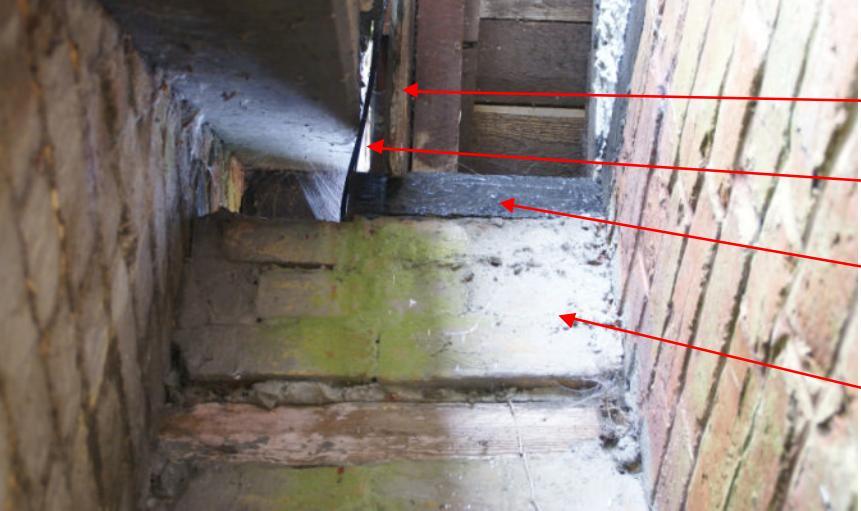
Upward view of roof construction from south side gap between buildings

Underside of roof gable verge tiling of Lodge building (Phase 1)

Underside of gable soffit of Lodge building (Phase 1)

Underside of gable barge board of later 2-roon structure (Phase 2)

Note gap between roof structures (daylight)

Top edge of roof covering to subsequent link structure (Phase 3)

South brick wall of subsequent link structure (Phase 3) Note poor incomplete finish

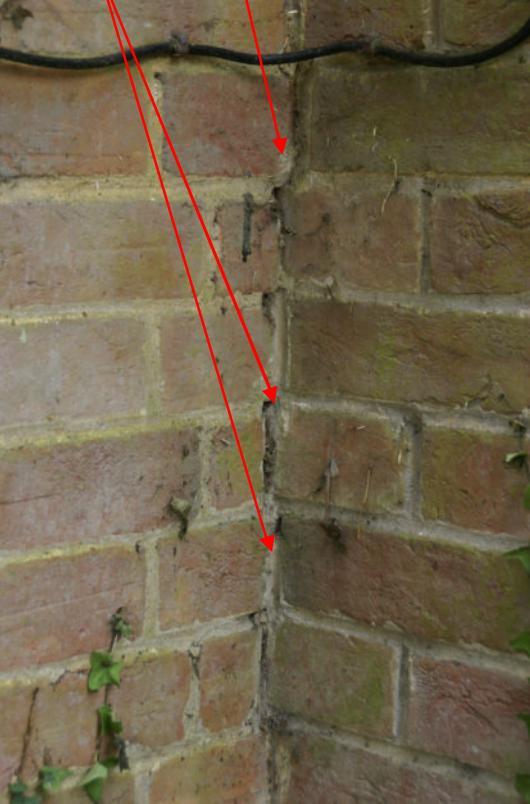
Probably due to the inconvenience of having to leave one building to go to the other, it appears that the link (Phase 3) structure was inserted between the buildings only a short time after. This has only approx 115mm thick brick walls laid in stretcher bond, the bricks appearing to be from the same source (same colour, texture and size) of the 2-Room section. Where this link meets the 2-Room section it can be seen that the original brickwork has been cut into at alternate courses to facilitate full toothing and bonding in of the new brickwork.

Alternate course by course bonding in of brickwork (same sized bricks)

Note cutting into earlier brickwork

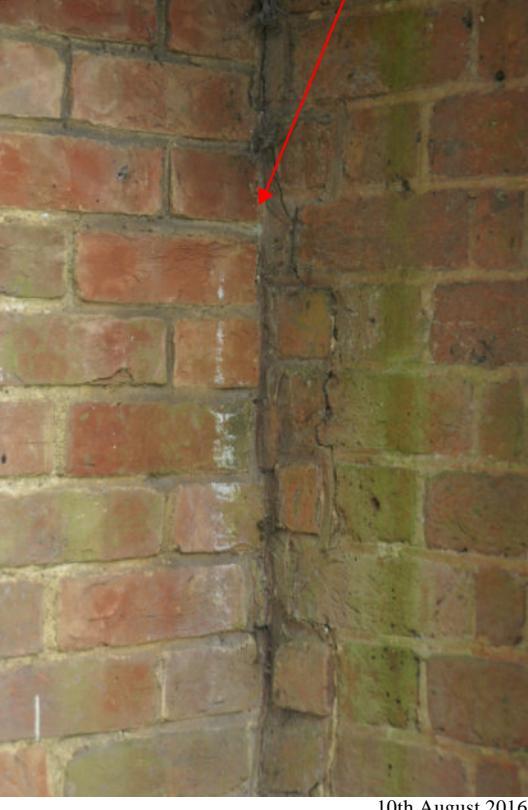
However, where the link meets the Lodge building it was not possible to achieve such neat bonding as the bricks to each structure differ in size, the courses not coinciding. Consequently, the new brickwork was bonded to the old by block bonding.

Block bonding in of brickwork due to mismatch in coursing of differing sized bricks
